BTSA-3 No Comm Modification

Ave Sako
11/2014
6/4/15, 11/19/15

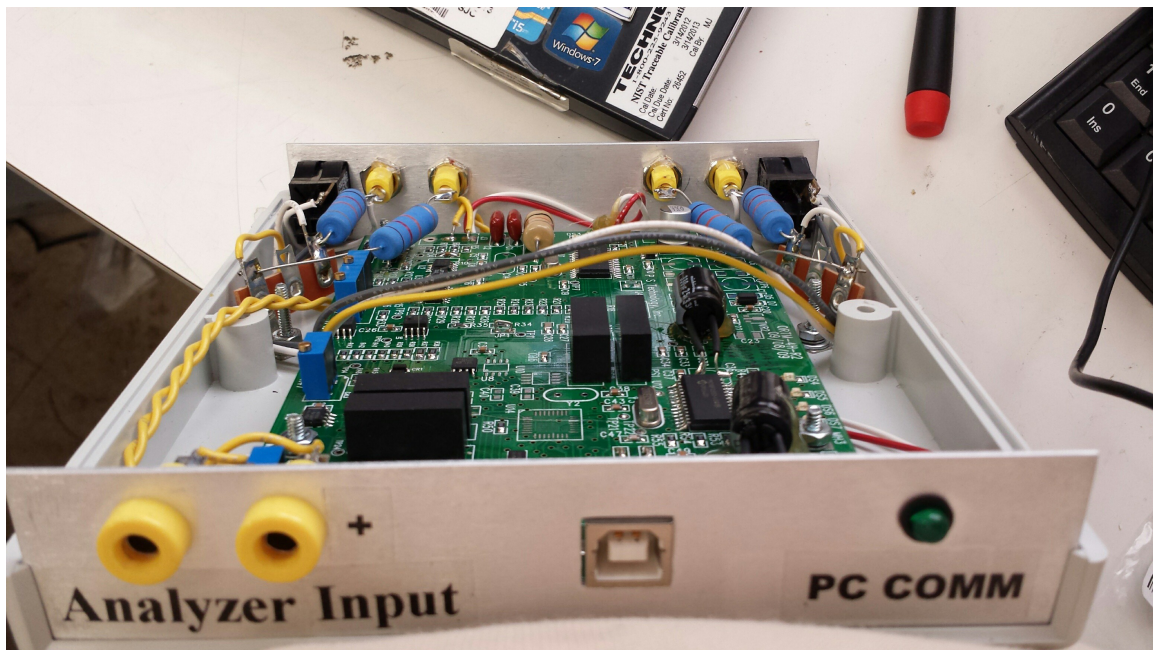
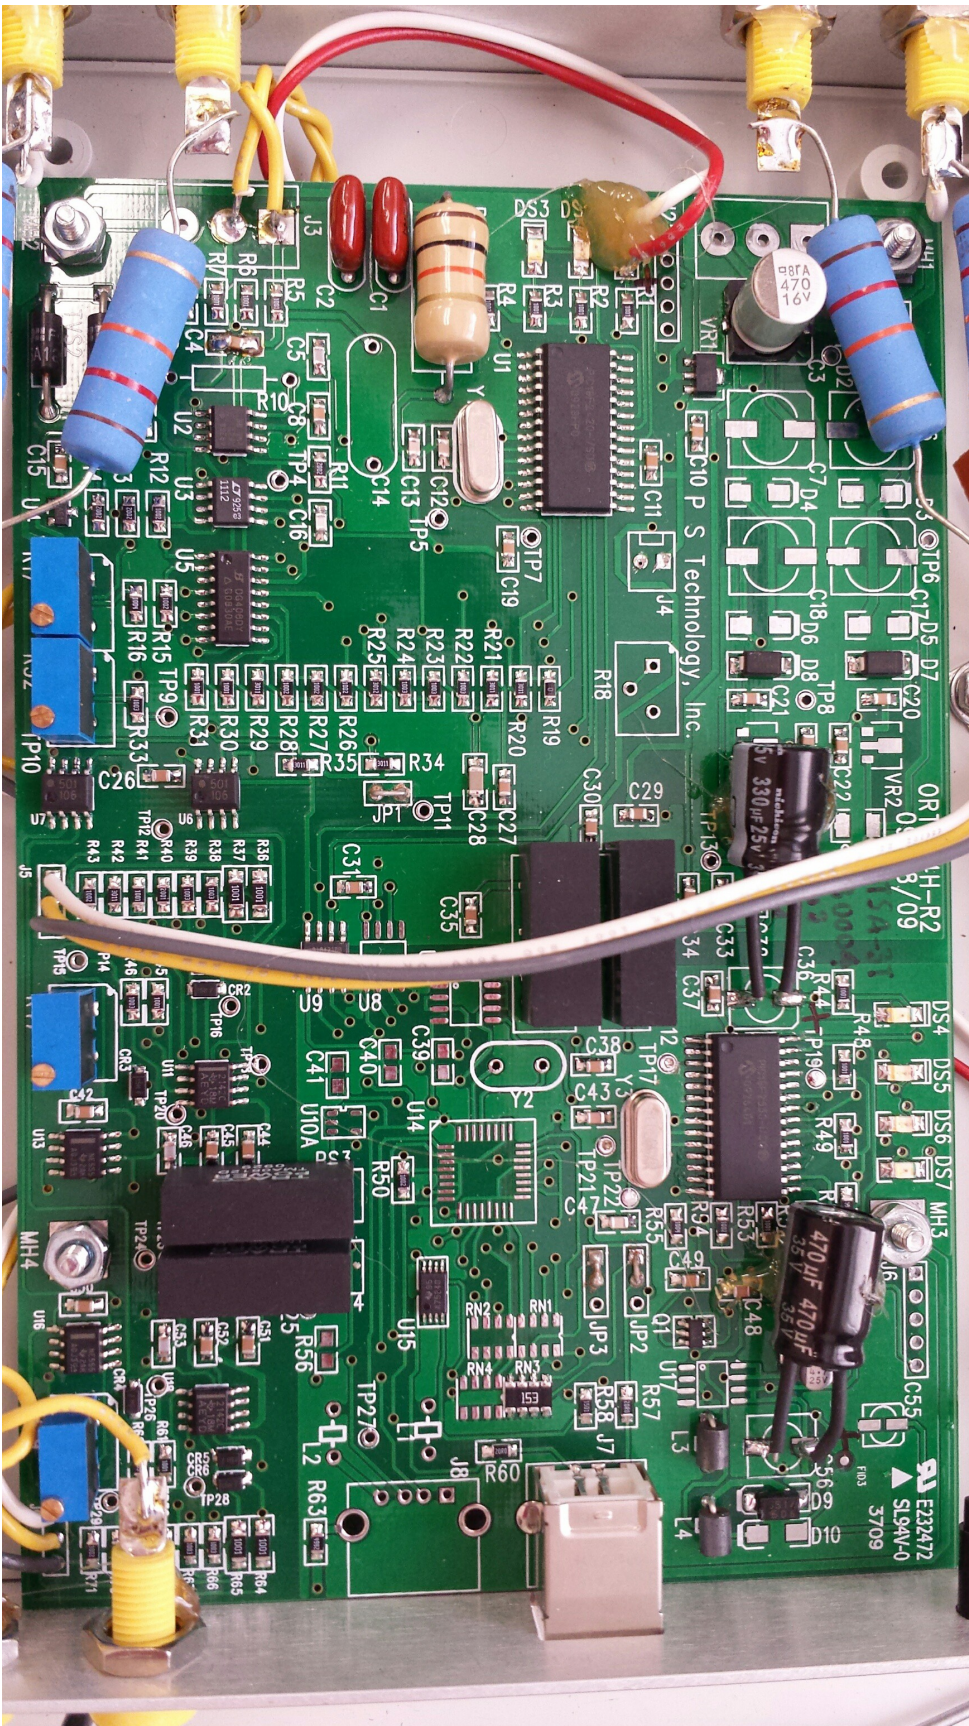
The Analyzer doesn't operate with all USB ports. This is caused by the current needed to run the BTSA. If the PC's hardware decides there's too much of a load, it turns off the port. Sometimes, the PC will cycle connect-unconnect. The severity of the problem is complicated by the length of USB cable and the individual requirements of the PC hardware. It seems intermittent depending on the PC used and PCB revision. The problem is mitigated by adding supply capacitors that are about 10X original value and re-wired the unit to make the front-panel LED blink when PC COM is achieved. This lowers the in-use current draw several milliamps, provides the board with enough power to operate, and gives the user an indication that the software may be started.

1. A few inch extension is soldered to the green LED's wires and used in place of DS1. Anode is closest to R1. Cover wires with hot glue. The pads need to be accessible for the 5Hz calibration test (not shown in photo).
2. C56 changed to 470uF (MB126) **Change C56 FIRST**, then try to connect to PC. Newer revision PCB's apparently don't require both capacitors.
3. C36 changed to 330uF (MB125) **Change C36 LAST**

Make polarity notation before removing original capacitors.
Heatshrink the capacitor leads and mount as shown. Affix with hot glue.
